TEST REPORT

ref. No. 412502675

Sample: Planter Eco
Logicbase V-SL

Determination of root puncture resistance

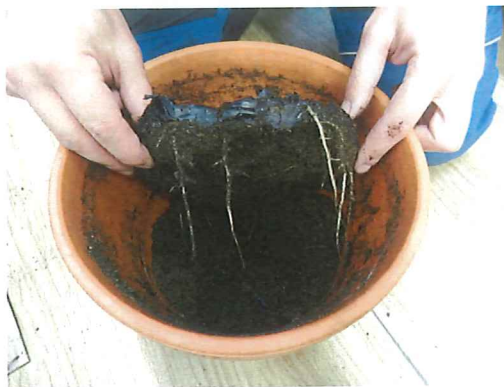
Photo No. 1 - Control of the vitality of the plants – The roots penetrated bitumen layer

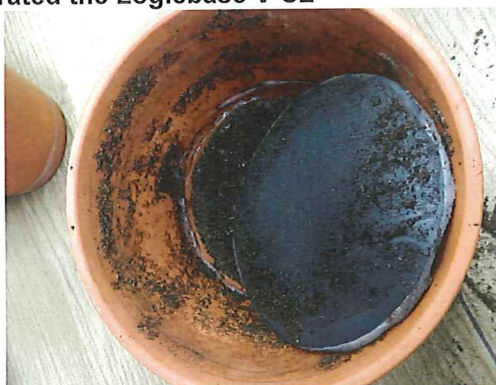
Photo No. 4 and 5 – The roots have not penetrated the Logicbase V-SL

Table No. II – Logicbase V-SL – ref.No. 2675/S/2

Characteristics measured	Unit	Test results
Roots puncture	-	The roots have not penetrated the samples
